SUSQUEHANNA RIVER BASIN

EATON BROOK RESERVOIR DAM

INVENTORY NO. N.Y. 352

**PHASE I INSPECTION REPORT
NATIONAL DAM SAFETY PROGRAM**

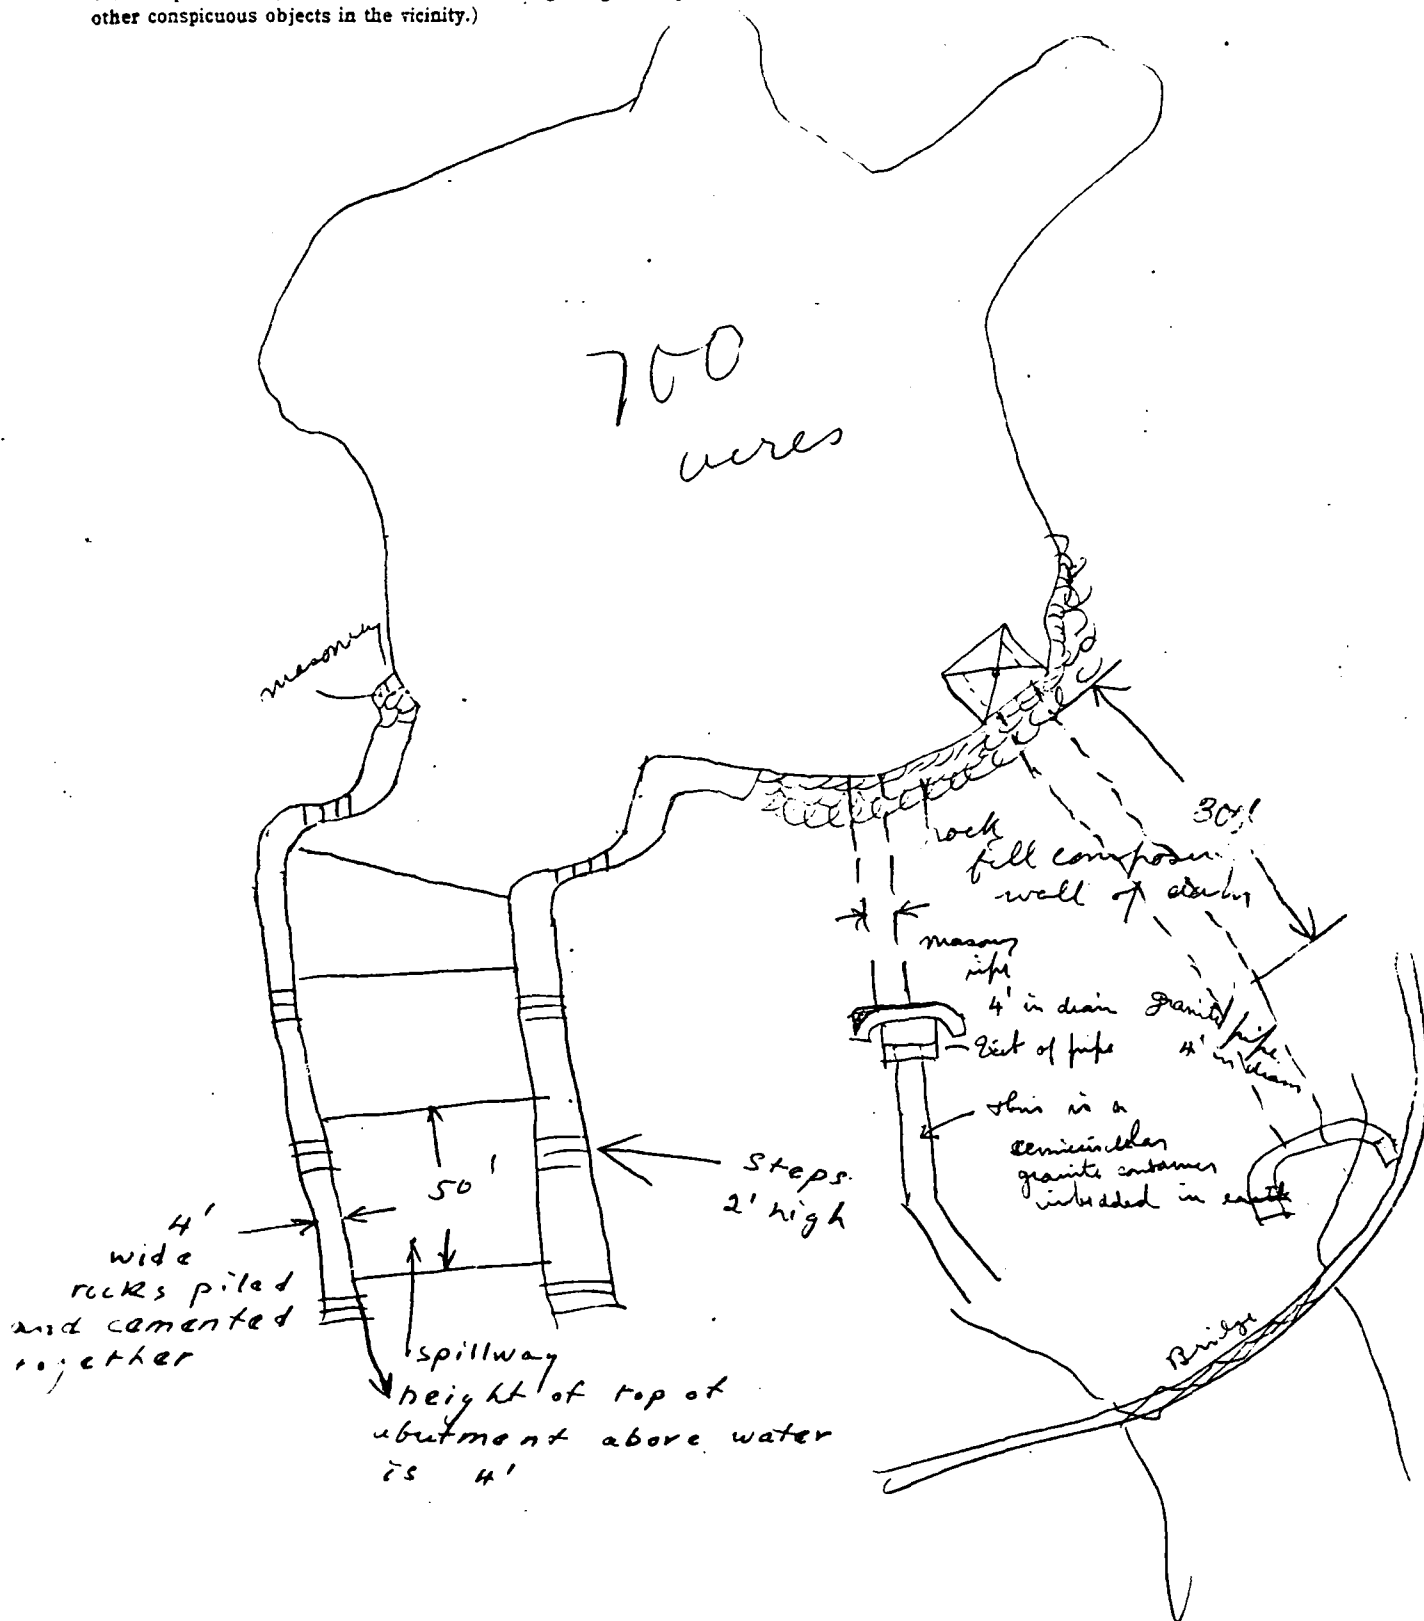
(In the space below, make a third sketch showing the general plan of the dam, and its approximate position in relation to buildings or other conspicuous objects in the vicinity.)

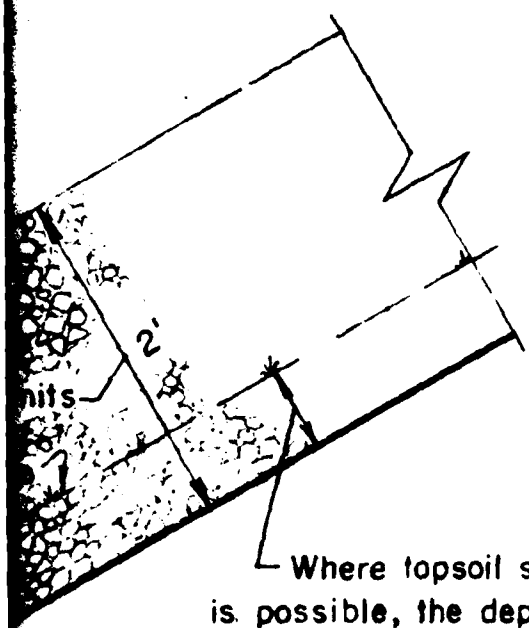
TREATMENT DETAIL FOR STRIPPING TRANSITION NO SCALE

Wherever topsoil stripping is eliminated, the Filter Fabric shall be placed directly on the original ground surface.
